Modernist unreinforced masonry (URM) buildings of Barcelona.

Seismic vulnerability and risk assessment

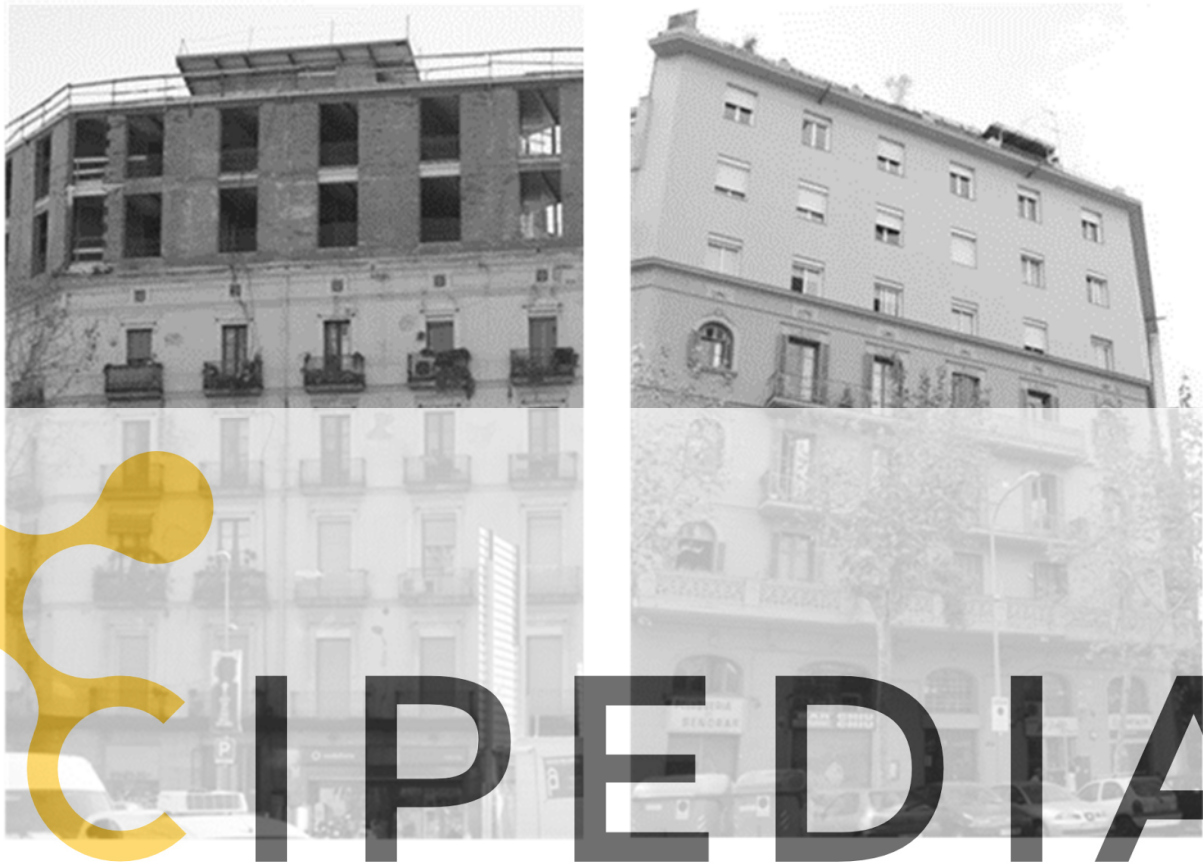
Figure 1. Example of URM buildings with high seismic vulnerability. The addition of top levels to the original buildings increases even more their seismic vulnerability.

building load conditions, increased their overall vulnerability (Figure 1). Therefore, the vulnerability of these URM buildings, the important population density and the not negligible seismic hazard in the region, decisively increased the seismic risk in these urban areas.

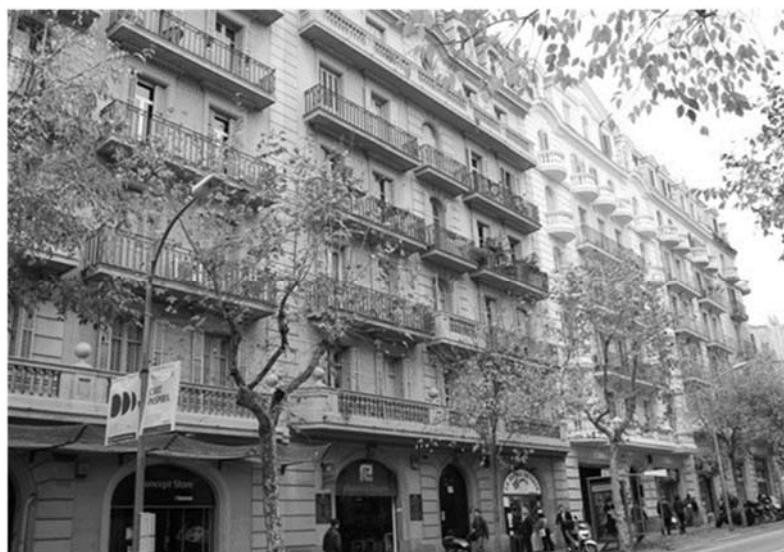
Figure 4. Façades of the analyzed buildings located in Barcelona.

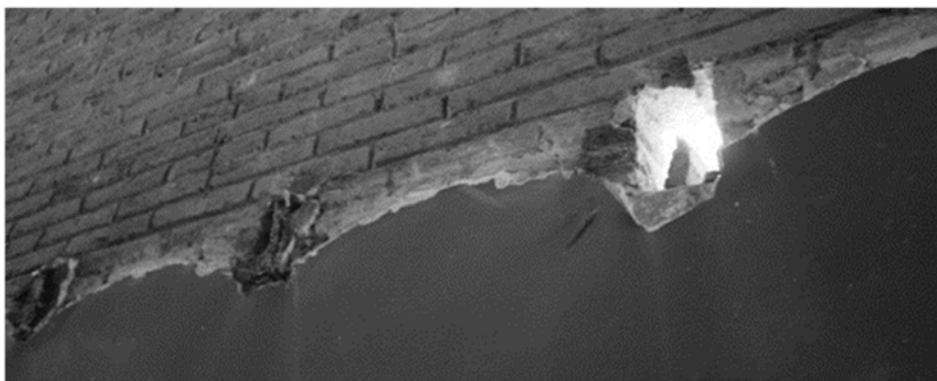
Figure 7. Iron beams (sliced) simply supported on the wall.

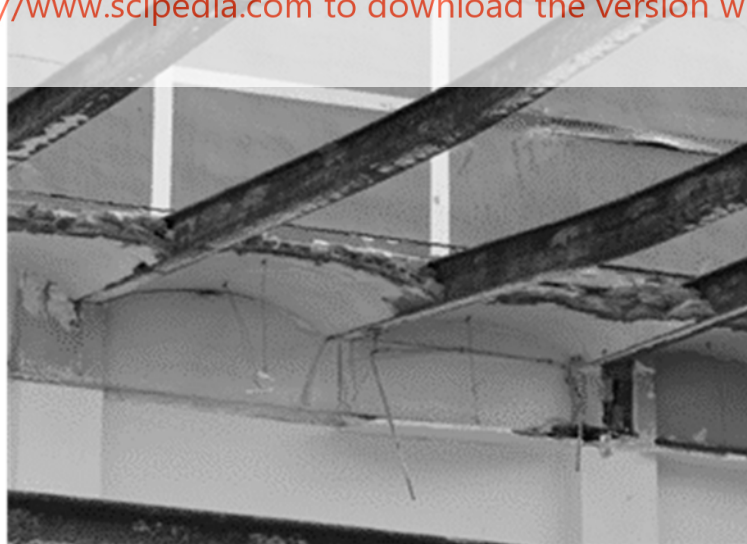
Figure 10. Details of a floor system observed during the demolition of an Eixample building.

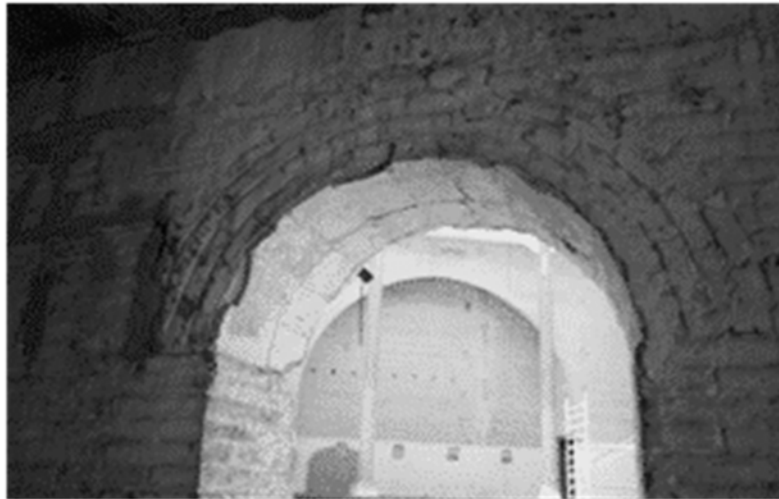
Figure 11. Example of distribution of the arches above openings.

In the URM buildings of the Eixample, the doorways and window spans use discharging arches or iron lintels (Figure 11). For openings in thin walls, as is the case of the distribution walls, the option was to use wood elements for the lintels of the doorways and windows. In big openings, the lintels are made with two, three or more beams, according to the wall thickness (one beam for each 15 cm of wall thickness), and are placed parallel to each other. The beams are fastened with bolts housed into iron tubes that maintain the beams at the required distance. The length of the beams support onto the walls can be taken as the edge length of the beam but, in any case, it is inferior to 20 cm (Figure 12).

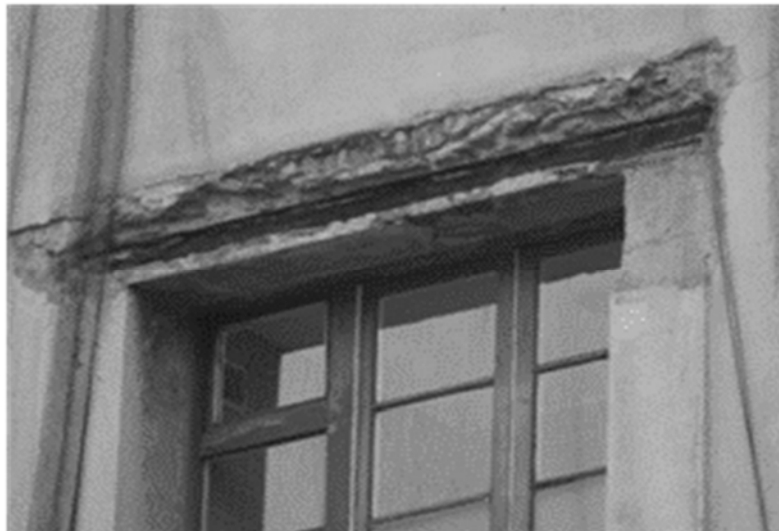
Figure 12. Support length for the beams located above openings.
